Asbestos Refurbishment/Demolition

Site Address: Castle Street, Mohill, Leitrim

Client: Sweeney Architects

Survey No.: D66131023

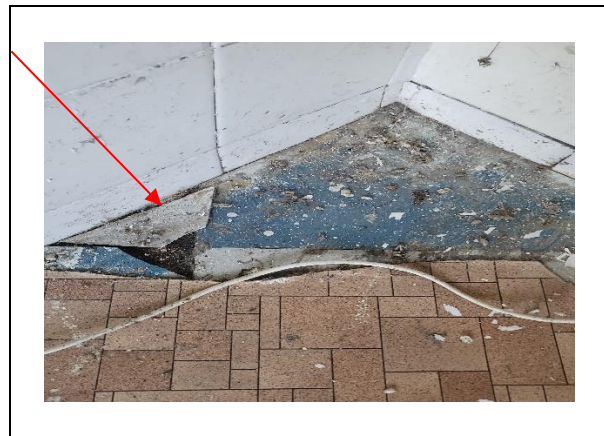
Survey No.	D66131023
Survey Type	Refurbishment and Demolition Survey
Survey Date	13/10/23
Surveyor	Stephen Cullen
Client Name	Sweeney Architects
Site Address	Castle Street, Mohill, Leitrim
Location	White Floor Tile - Kitchen
Sample Range	Sample 1

Product type	Floor Tile	Score	1
Extent of damage/deterioration	Medium	Score	2
Surface treatment	None	Score	1
Asbestos type	Chrysotile	Score	1
		Total	5

Remove any Asbestos containing material affected by refurbishment works or in poor condition or label and manage and review every 12 months if not affected.

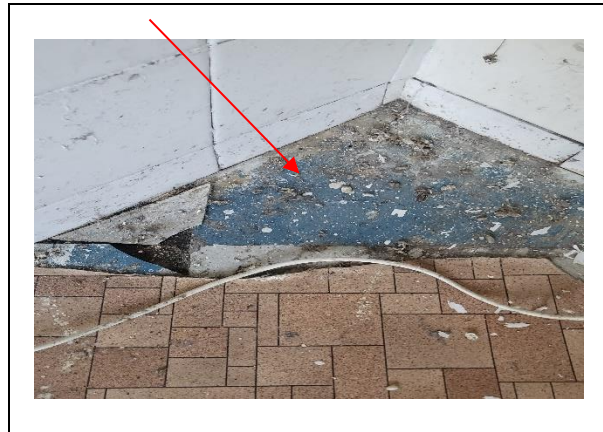
Survey No.	D66131023
Survey Type	Refurbishment and Demolition Survey
Survey Date	13/10/23
Surveyor	Stephen Cullen
Client Name	Sweeney Architects
Site Address	Castle Street, Mohill, Leitrim
Location	Black Floor Tile - Kitchen
Sample Range	Sample 2

Product type	Floor Tile	Score	1
Extent of damage/deterioration	Medium	Score	2
Surface treatment	None	Score	1
Asbestos type	Chrysotile	Score	1
		Total	5

Remove any Asbestos containing material affected by refurbishment works or in poor condition or label and manage and review every 12 months if not affected.

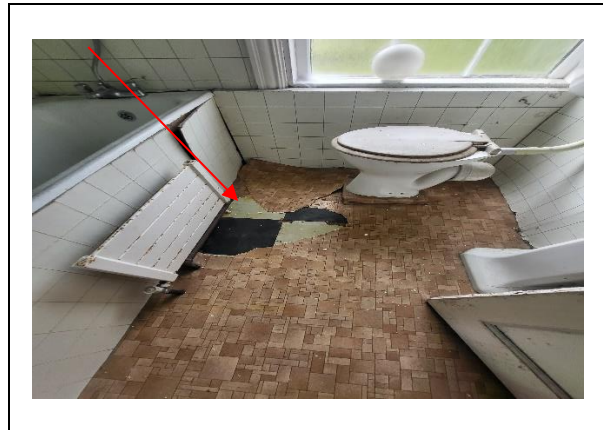
Survey No.	D66131023
Survey Type	Refurbishment and Demolition Survey
Survey Date	13/10/23
Surveyor	Stephen Cullen
Client Name	Sweeney Architects
Site Address	Castle Street, Mohill, Leitrim
Location	White Floor Tile – Bathroom Upstairs
Sample Range	Sample 3

Product type	Floor Tile	Score	1
Extent of damage/deterioration	Medium	Score	2
Surface treatment	None	Score	1
Asbestos type	Chrysotile	Score	1
		Total	5

Remove any Asbestos containing material affected by refurbishment works or in poor condition or label and manage and review every 12 months if not affected.

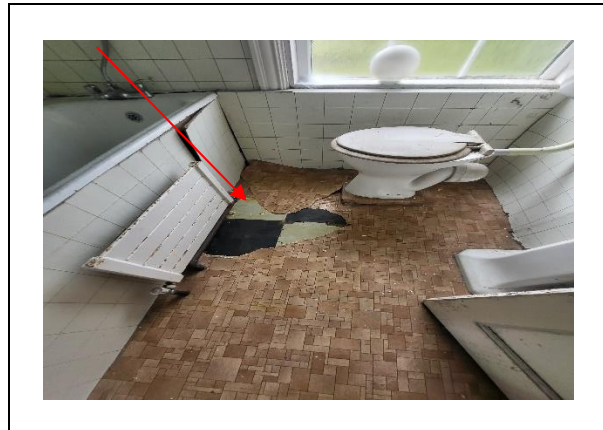
Survey No.	D66131023
Survey Type	Refurbishment and Demolition Survey
Survey Date	13/10/23
Surveyor	Stephen Cullen
Client Name	Sweeney Architects
Site Address	Castle Street, Mohill, Leitrim
Location	White Floor Tile – Bathroom Upstairs
Sample Range	Sample 4

Product type	Floor Tile	Score	1
Extent of damage/deterioration	Medium	Score	2
Surface treatment	None	Score	1
Asbestos type	Chrysotile	Score	1
		Total	5

Remove any Asbestos containing material affected by refurbishment works or in poor condition or label and manage and review every 12 months if not affected.

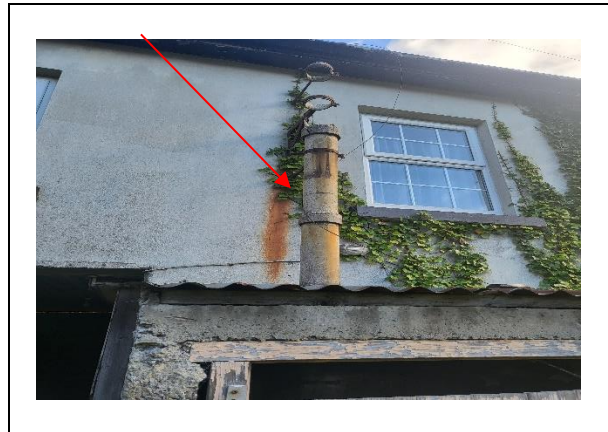
Survey No.	D66131023
Survey Type	Refurbishment and Demolition Survey
Survey Date	13/10/23
Surveyor	Stephen Cullen
Client Name	Sweeney Architects
Site Address	Castle Street, Mohill, Leitrim
Location	Outhouse - Rear of Building
Sample Range	Presumed

Product type	Asbestos Cement Flu Pipe	Score	
Extent of damage/deterioration	N/A	Score	
Surface treatment	N/A	Score	
Asbestos type	Chrysotile + Amosite + Crocidolite	Score	
		Total

Presumed Asbestos Cement Flu Pipe
