Refurbishment / Demolition Asbestos Survey (RDAS) 52 New Road Thomondgate Limerick

Date: 9 th October 2023	
Surveyor: James McCusker

Client	Limerick City & County Council.
Project Title	RDAS – No. 52 New Road Thomondgate Limerick
Document Title	Refurbishment / Demolition Asbestos Survey (RDAS) No. 52 New Road Thomondgate Limerick
Report No:	Report No: A071/23

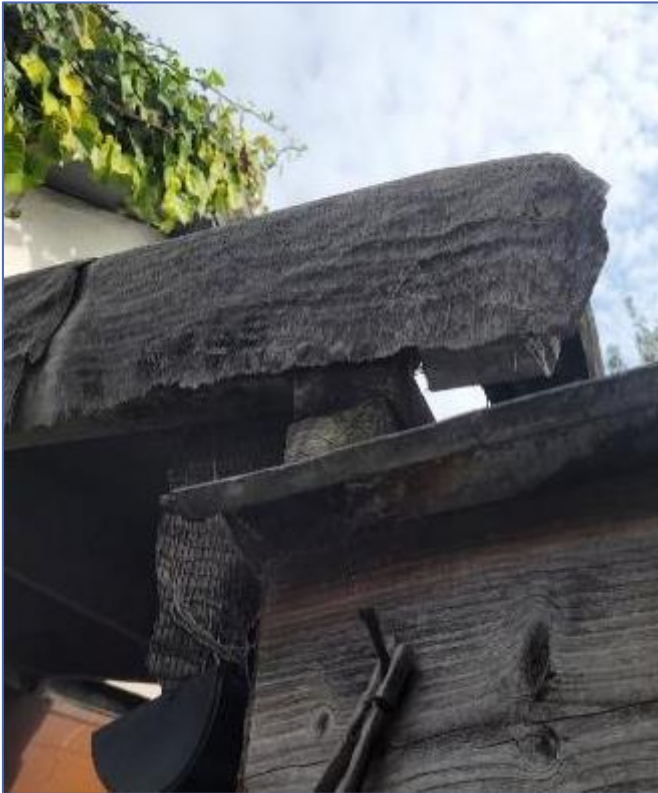
Location	Sample No:	Result of analysis										
Sarking Felt – Cold Room

A	No Asbestos Identified										
	Extent	N/A										
Material Risk Assessment		Risk Rating										
Asbestos type: - Type of product: - Condition: - Surface Treatment: -	N/A

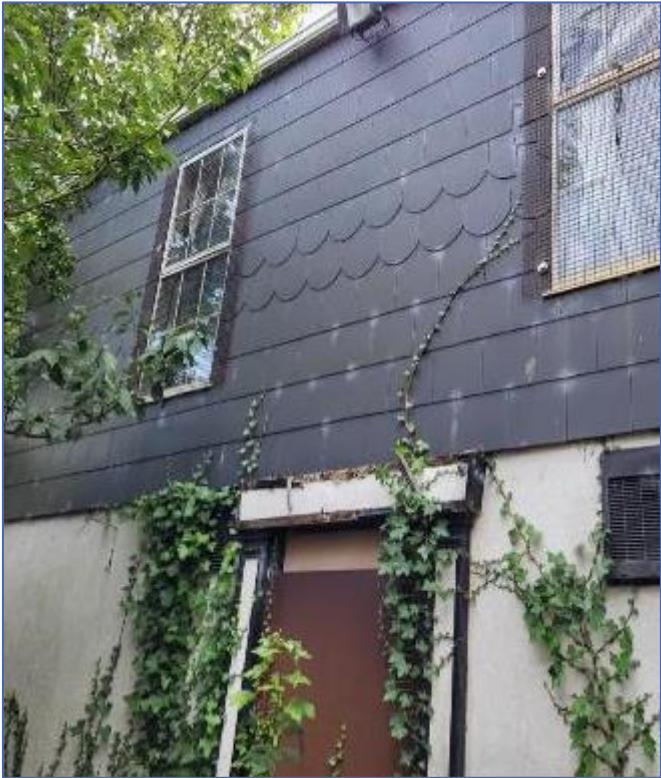
Location		Sample No:	Result of analysis
Extension / Side Cladding Slate		B	Chrysotile Asbestos Identified

Extent	As seen
Material Risk Assessment		Score	Risk Rating
Asbestos type: -	Chrysotile	1	High Risk
Type of product: -	Cement Slate	1	Medium Risk
Condition: -	Medium Damage	2	Low Risk
Surface Treatment: -	Non-friable	0	Very Low Risk
		4	Very low risk

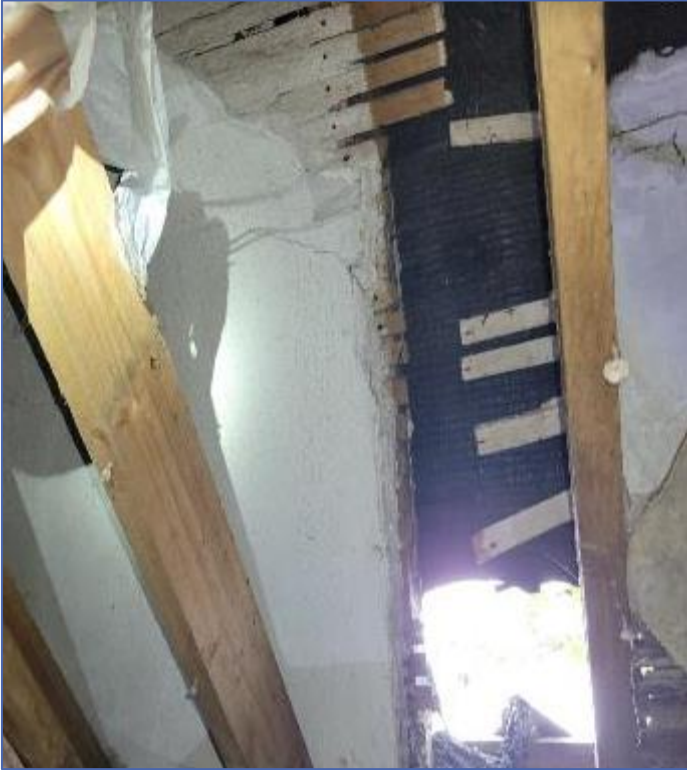
Location	Sample No:	Result of analysis
Main Roof - Sarking Felt

C	No Asbestos Identified
	Extent	N/A
Material Risk Assessment		Risk Rating
Asbestos type: - Type of product: - Condition: - Surface Treatment: -	N/A	Score 0 0 0 0
		<div style="background-color: red; color: white; padding: 2px;">High Risk</div> <div style="background-color: #4a7ebb; color: white; padding: 2px;">Medium Risk</div> <div style="background-color: #c08080; color: white; padding: 2px;">Low Risk</div> <div style="background-color: #ffff00; color: black; padding: 2px;">Very Low Risk</div>
		No Asbestos

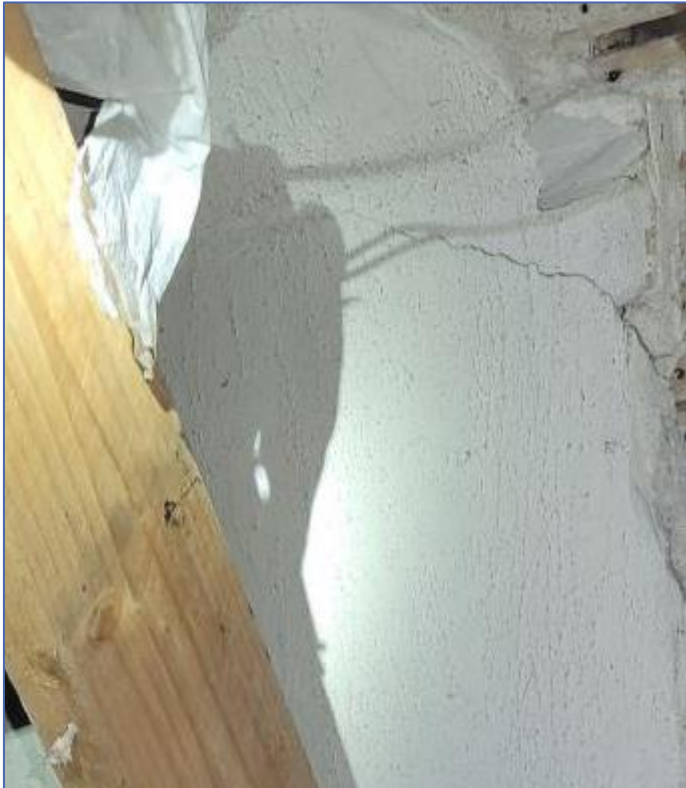
Location	Sample No:	Result of analysis
Original Ceiling - Artex

D	No Asbestos Identified
	Extent	N/A
Material Risk Assessment		Risk Rating
Asbestos type: - Type of product: - Condition: - Surface Treatment: -	N/A	0 0 0 0
		<div style="background-color: red; color: white; padding: 2px;">High Risk</div> <div style="background-color: #4682b4; color: white; padding: 2px;">Medium Risk</div> <div style="background-color: #d2b48c; color: white; padding: 2px;">Low Risk</div> <div style="background-color: yellow; color: black; padding: 2px;">Very Low Risk</div>
		No Asbestos

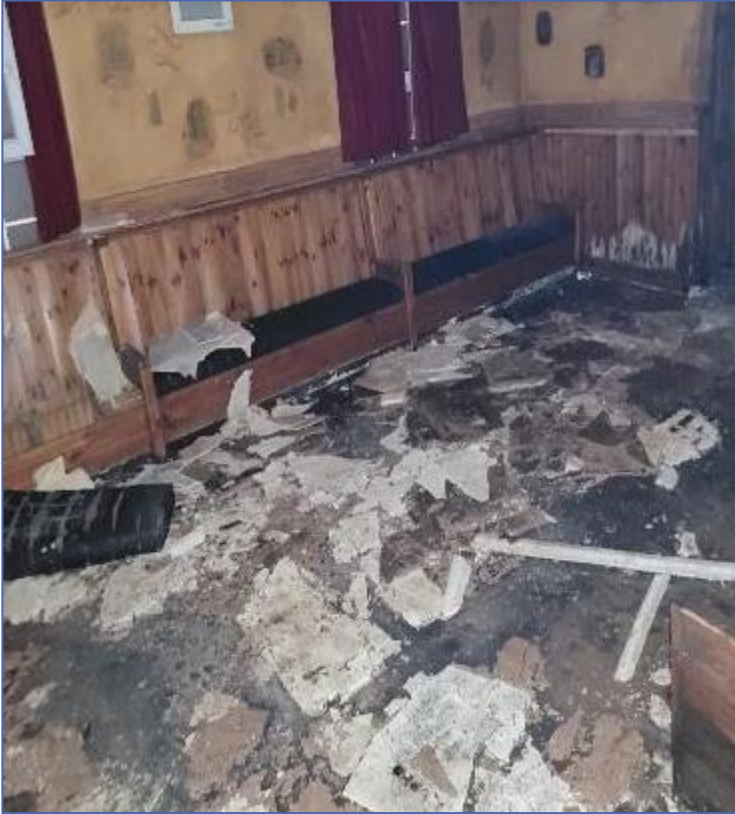
Location	Sample No:	Result of analysis
Ground Floor Bar Ceiling - Artex

E	No Asbestos Identified
	Extent	N/A
Material Risk Assessment		Score
Asbestos type: - Type of product: - Condition: - Surface Treatment: -	N/A	0 0 0 0
		Risk Rating
		High Risk
		Medium Risk
		Low Risk
		Very Low Risk
		No Asbestos

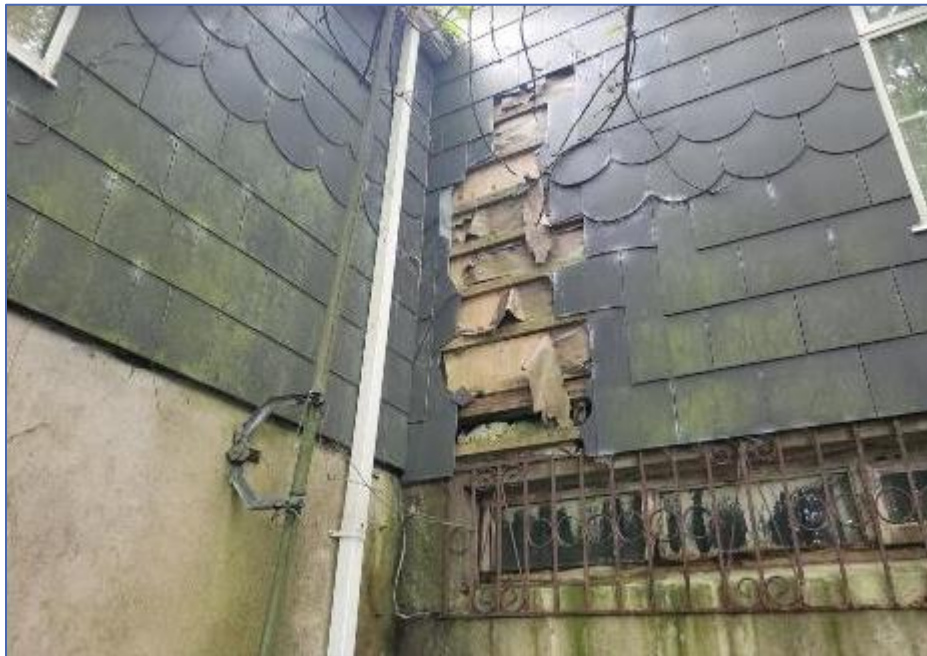
Asbestos Roof Slates to rear – Poor condition

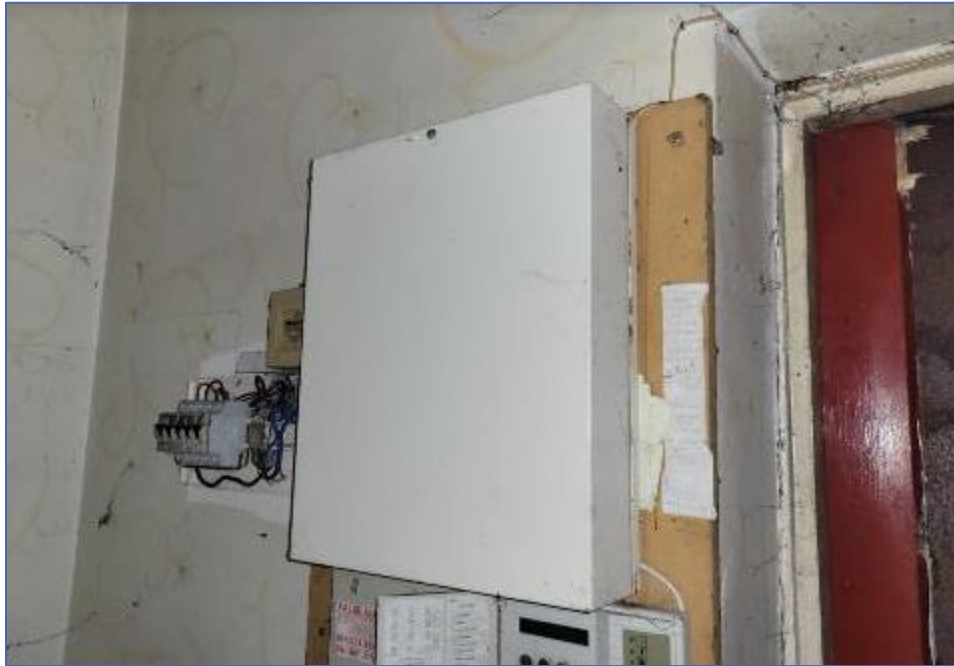
Electrical Units – No suspect materials

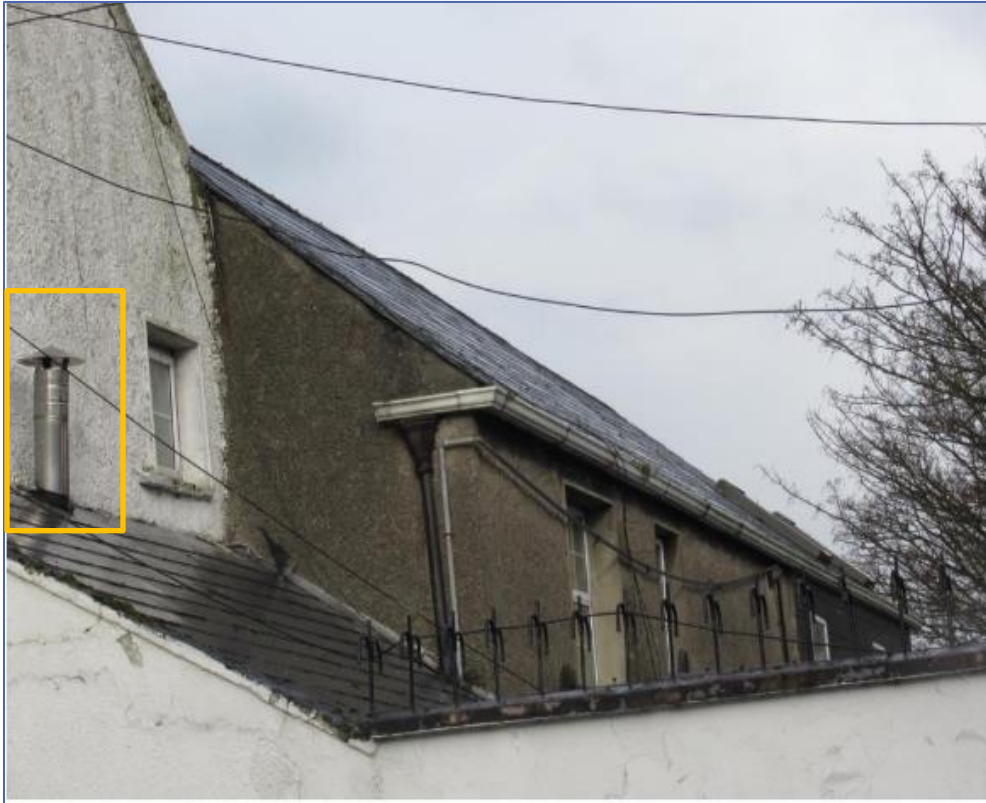
- A lean too area to the right-hand side of the building across from the Cold room was inaccessible.
- If any suspect materials are found in this area, then further investigation needs to be carried out.

Inaccessible Area with Steel Flue Pipe
