**Bat survey and building inspection,
Main Street, Ballinamore, Co. Leitrim**

For: dhb Architects, Waterford

October 2023

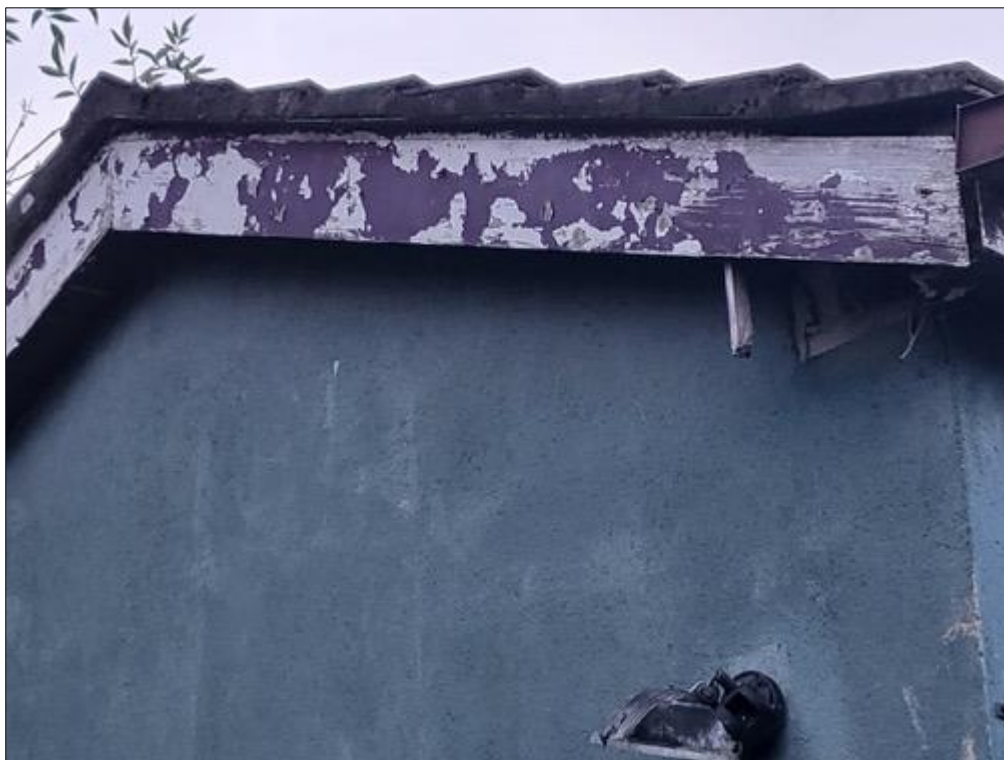
The exterior of the building was scanned for features that may be of use to bats to access the building. Such features included missing roof slates, structural cracks in the building and rotting or damaged soffits and fascias. Some gaps in the roof slates were noted. The fascias of the rear extension part of the building are in a generally poor state and provide potential features for bats however it was noted that the timber is decaying in places due to wet induced rot, rendering it as having a low suitability for roosting bats, Figure 4.

Figure 4. *Fascia along the rear extension gable.*

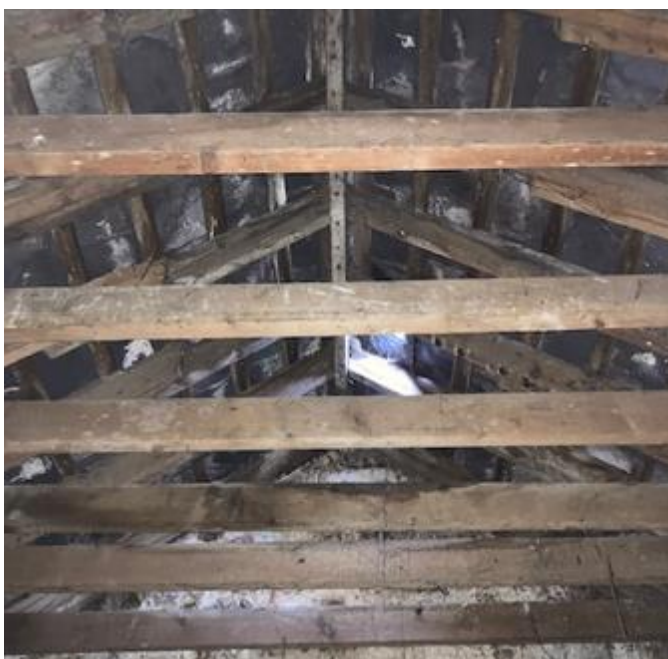
Access was allowed to the attic via a trapdoor. Although the attic was largely dry, a hole in the roof where a tile is missing has allowed ingress of water. There was no evidence of any bat habitation but there was an abundance of cobwebs. The latter would indicate no regular use of the attic space by bats.

Figure 7. Attic space – note missing roof tile

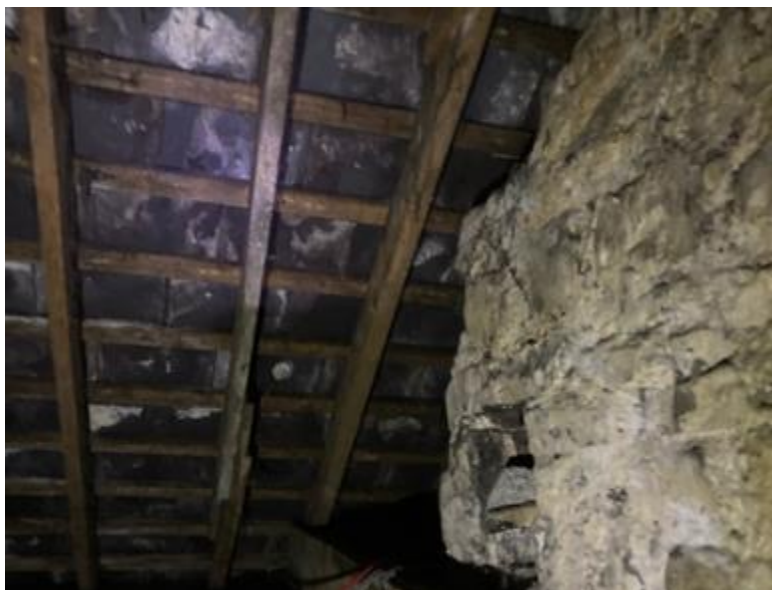
It should be noted that there is a stone-built party wall between the landing and the front bedroom. This disallowed access and inspection. While it is unlikely that bat roosts occur here, this possibility cannot be ruled out. This section of the roof should therefore be dismantled by hand should there be any roosting bats here.

Figure 8. Attic space – the stone construction party wall shown to the right of photograph.

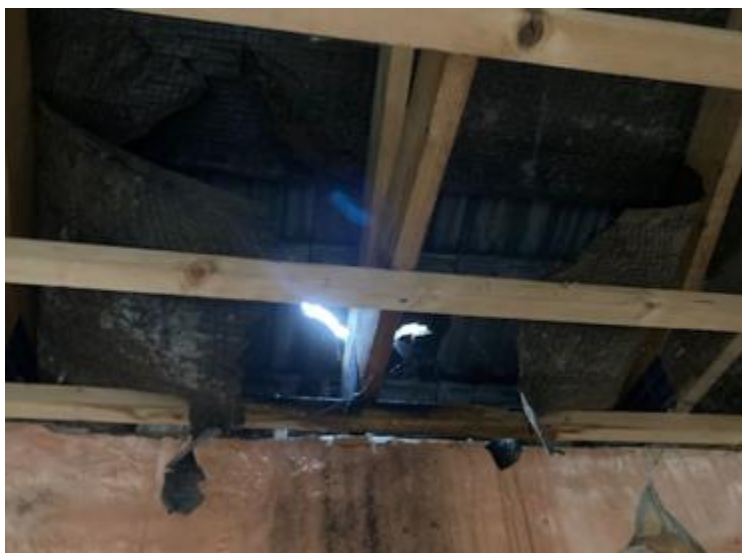
Figure 9. Gap in roof of function room.

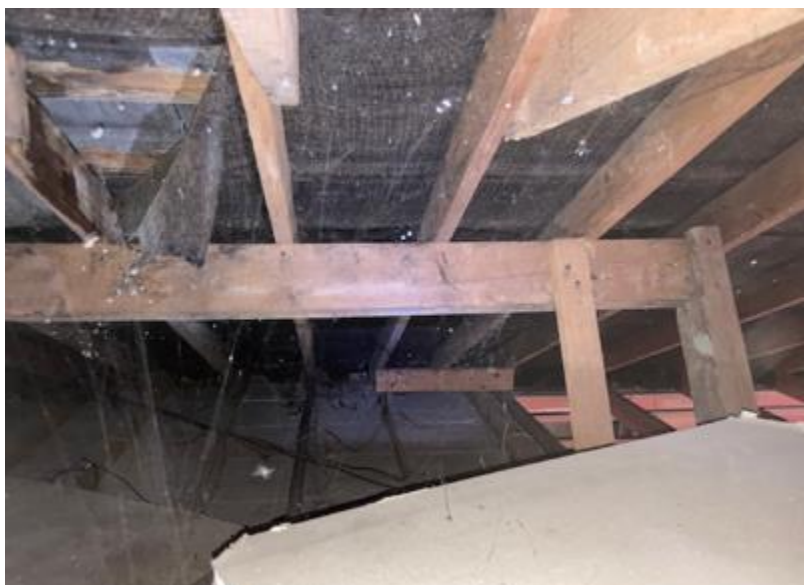
Figure 10. Roof space at rear of function room. Note abundance of cobwebs.

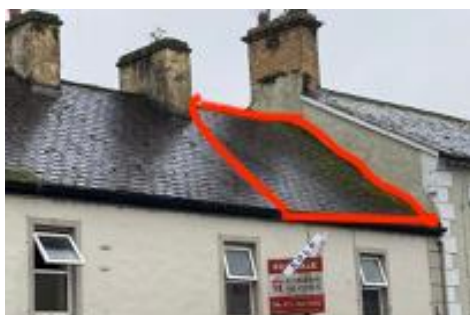
Figure 11. Section of roof where it is recommended that tiles be removed by hand.

Although the building search and emergence watch was undertaken outside of the optimal bat surveying season, May to September, the lack of evidence of bat presence, such as droppings, indicates that this building is not used by bats. However, surveys such as these represent a 'snapshot' in time and as bats are a transitional species and move between suitable roosting locations throughout the year, it is not possible to definitively confirm the absence of bats based on the low level of survey effort as was applied to this building. Based on the findings of the building inspection, no further surveys for bats, such as emergence and re-entry surveys are considered necessary. However, when the facias and soffits are being replaced, and other roof related works being undertaken, the work team should be vigilant for bats, as a precaution. As a portion of the attic space could not be searched, it is recommended that the roof tiles here are removed by hand.
