22/05/2024

PROJECT NO. L362

RE: OCSC ASSESSMENT OF EXISTING PUB STRUCTURE

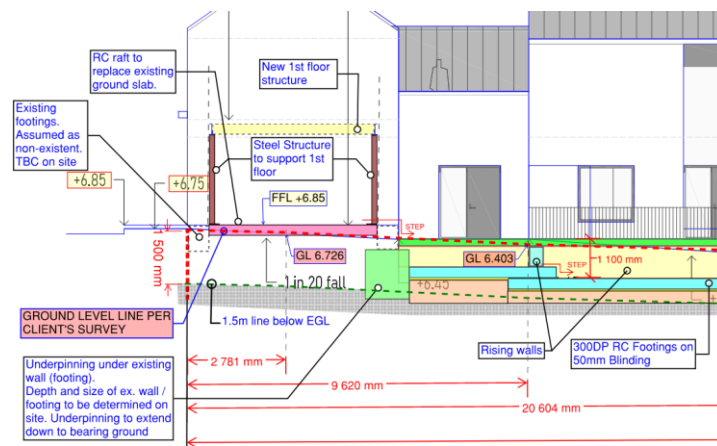
Extract from structural package outline works to the rear of the Pub structure.
