### **LEITRIM COUNTY COUNCIL**

Proposed Development at Sean Mac Diarmada Street,  
Manorhamilton, Co Leitrim

Foul, Surface Water, Water Supply,  
& Calculations

**Project Description:** CCTV Survey

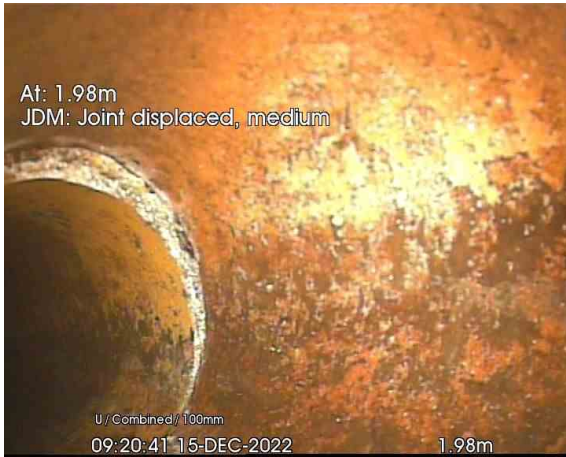
Scale:	1:50	Position [m]	Code	Observation	MPEG	Photo	Grade
		Depth: m UPS2					
		0.00	MH	Start node, manhole, reference: UPS2	00:00:00		
		0.00	WL	Water level, 5% of the vertical dimension	00:00:00		
		1.82	LL	Line deviates left	00:00:15		
		1.98	JDM	Joint displaced, medium	00:00:23	MH1 TO UPS2_1-9 8m_09204	1 / 3
		3.03	LU	Line deviates up	00:00:29		
		3.03	MHF	Finish node, manhole, reference: MH1	00:00:30		
		MH1 Depth: m

MH1 TO UPS2\_1-98m\_092041.jpg, 00:00:23, 1.98 m  
Joint displaced, medium

There is an existing 100mm foul sewer to the rear of the site servicing the existing dwellings. A CCTV of this sewer has been carried out. There are a few minor defects to be remediated prior to the new units being constructed. Please refer to Appendix A for a copy of the CCTV.

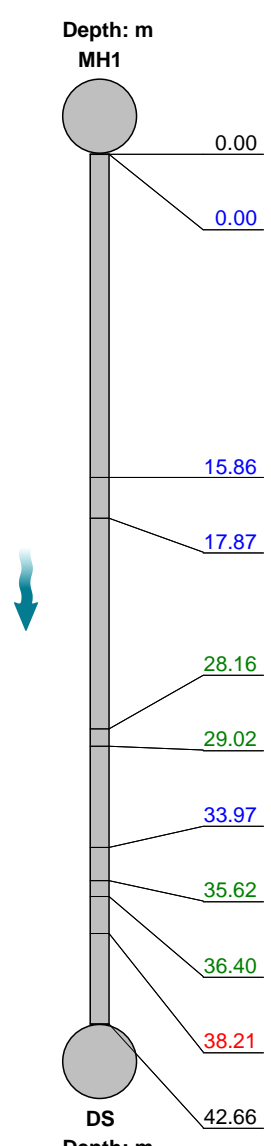
<table><tr> <td style="text-align: right;">0.00</td> <td style="text-align: center;">MH</td> <td>Start node, manhole, reference: MH1</td> <td style="text-align: right;">00:00:00</td> <td></td> <td></td> </tr><tr> <td style="text-align: right;">38.21</td> <td style="text-align: center;">D</td> <td>Deformed sewer or drain, 5%</td> <td style="text-align: right;">00:02:20</td> <td></td> <td style="text-align: right;">1 / 2</td> </tr></table>

</div>								0.00	MH	Start node, manhole, reference: MH1	00:00:00			0.00	WL	Water level, 5% of the vertical dimension	00:00:00			15.86	WL	Water level, 10% of the vertical dimension	00:00:49			17.87	WL	Water level, 5% of the vertical dimension	00:00:56			28.16	LR	Line deviates right: MANHOLE	00:01:26			29.02	LR	Line deviates right	00:01:34			33.97	WL	Water level, 10% of the vertical dimension	00:01:49			35.62	LL	Line deviates left: MANHOLE	00:01:57			36.40	LL	Line deviates left	00:02:05			38.21	D	Deformed sewer or drain, 5%	00:02:20		1 / 2	42.66	MHF	Finish node, manhole, reference: DS	00:02:51		
0.00	MH	Start node, manhole, reference: MH1	00:00:00																																																																						
0.00	WL	Water level, 5% of the vertical dimension	00:00:00																																																																						
15.86	WL	Water level, 10% of the vertical dimension	00:00:49																																																																						
17.87	WL	Water level, 5% of the vertical dimension	00:00:56																																																																						
28.16	LR	Line deviates right: MANHOLE	00:01:26																																																																						
29.02	LR	Line deviates right	00:01:34																																																																						
33.97	WL	Water level, 10% of the vertical dimension	00:01:49																																																																						
35.62	LL	Line deviates left: MANHOLE	00:01:57																																																																						
36.40	LL	Line deviates left	00:02:05																																																																						
38.21	D	Deformed sewer or drain, 5%	00:02:20		1 / 2																																																																				
42.66	MHF	Finish node, manhole, reference: DS	00:02:51

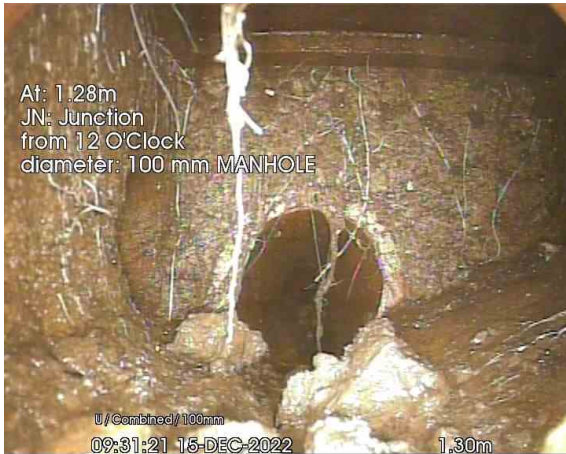
MH2 TO UPS5\_1-30m\_093121.jpg, 00:00:10, 1.30 m  
Junction at 12 o'clock, 100mm dia, MANHOLE
