This report was prepared in response to a request from Mr. John Carr, DBFL Consulting Engineers, for a Stage 1 Road Safety Audit for the proposed road and active travel links being part of an overall scheme for Monaghan County Council's new civic offices.

This Stage 1 Road Safety Audit has been carried out in accordance with the requirements of TII Publication Number GE-STY-01024, dated December 2017.

ST1 RSA-MONAGHAN CIVIC OFFICES
DBFL

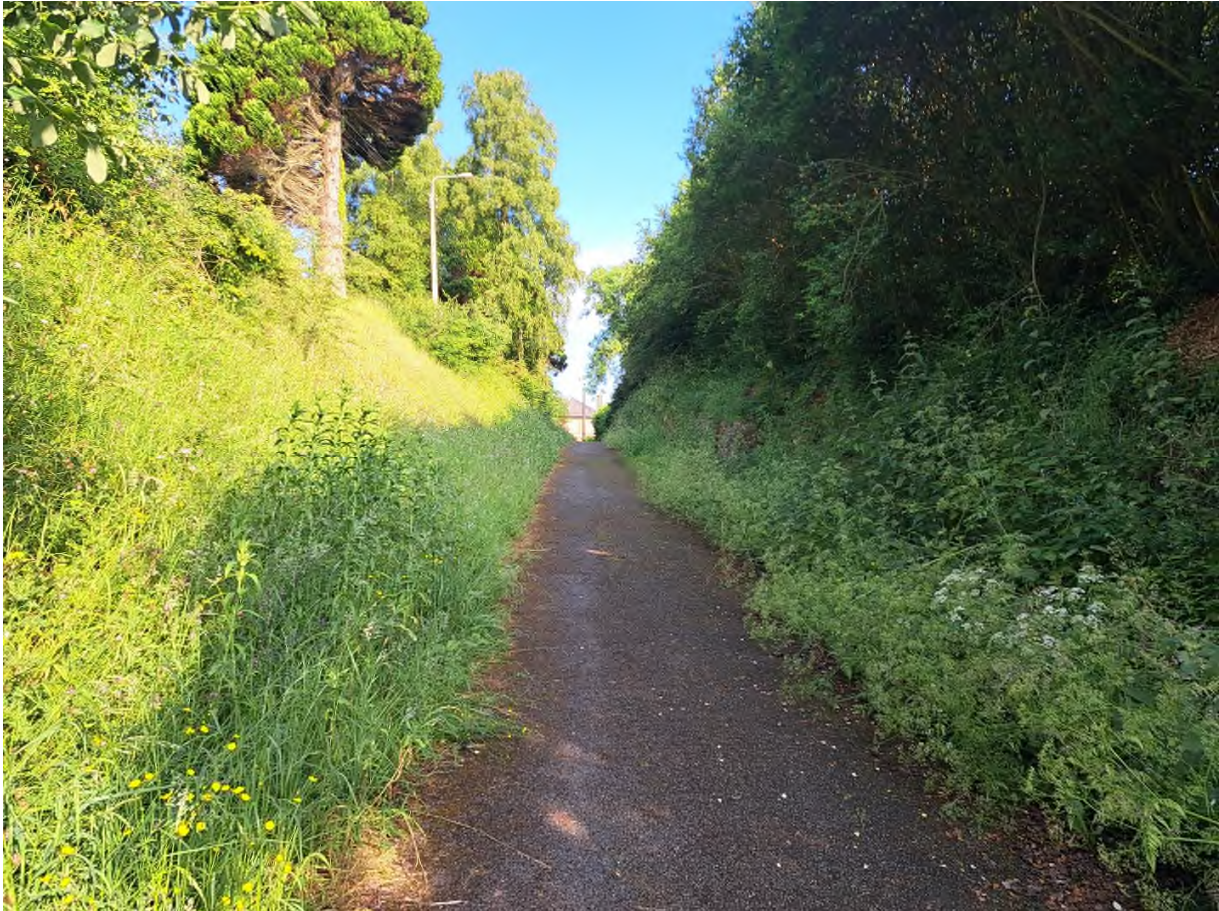
The existing pathway to Glaslough Street is very steep and may lead to loss of control for cyclists or overshoot into the carriageway by cyclists.

It is recommended that speed control measures be provided on the existing path.

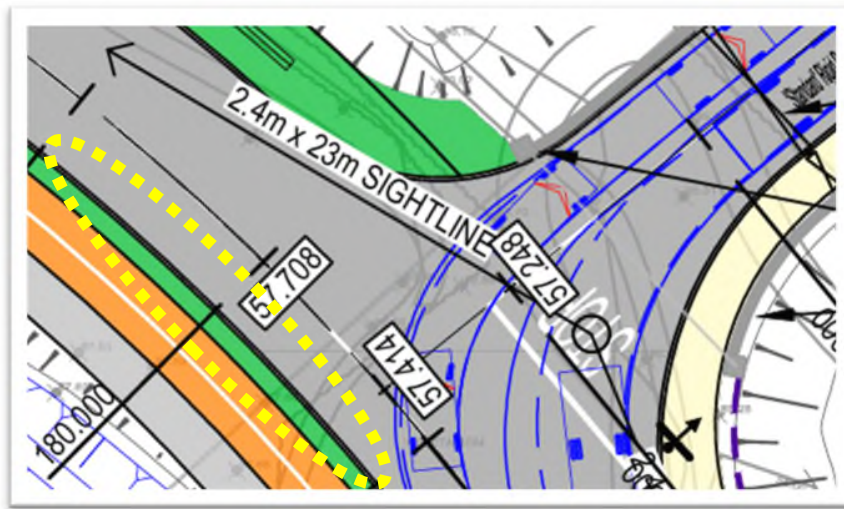
There is a risk that during high attendance fixtures at the GAA grounds that drivers will park on the verge and partially on the two-way cycle track thereby blocking the route for cyclists and leading to possible collisions with opening doors. Parking may also occur on the swale side of the new road.

It is recommended that preventative measures be provided to avoid parking overspill from the GAA grounds.
