Former Public House at Ballinamore

Bat Habitation Survey Report

For: DHB Architects
Date: 26 January 2024

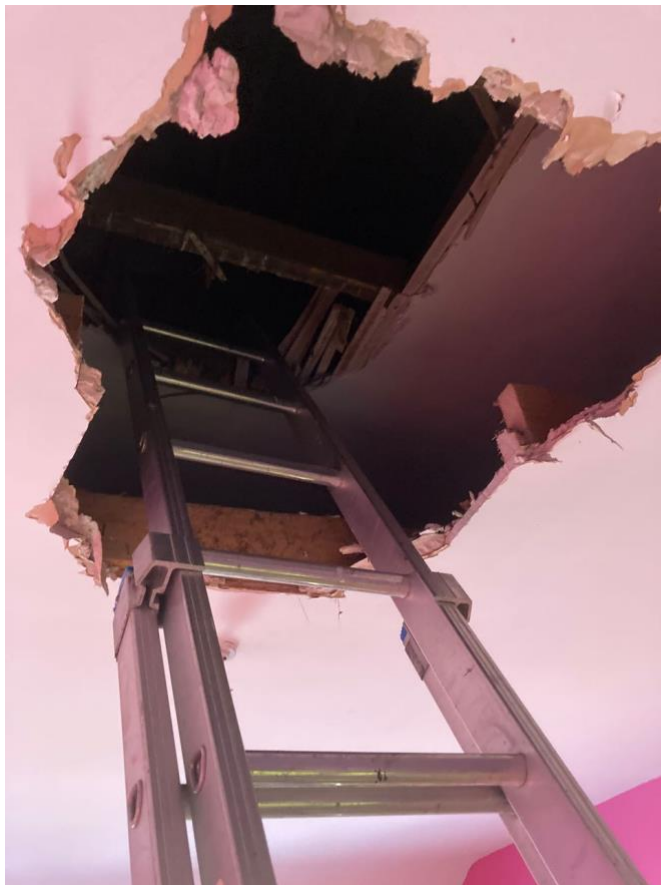
Fig. 1. Portion of ceiling removed by Leitrim County Council to allow access to attic areas

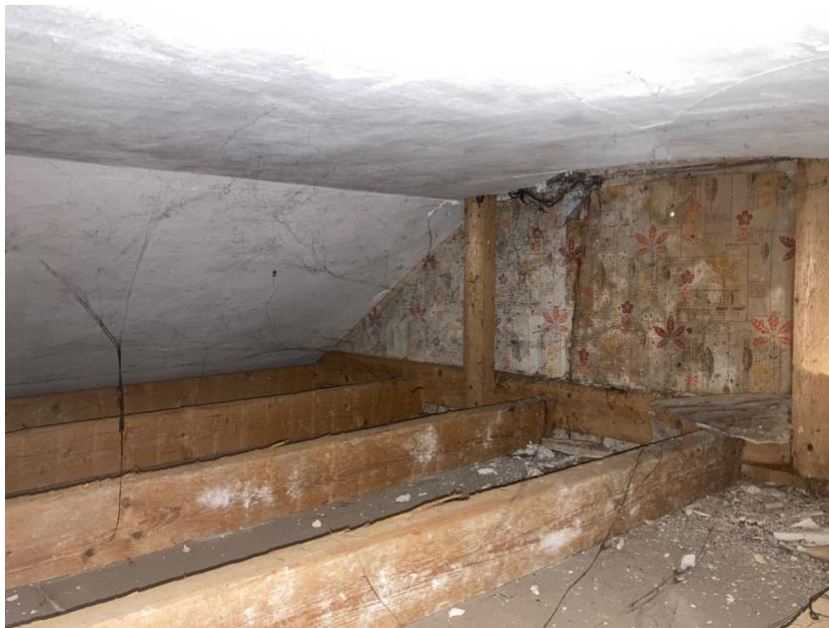
Fig. 2. Area within suspended ceiling over one of the first floor bedrooms.

All previously inaccessible areas of the attic space could be readily searched. It was noted that the attic was generally dry and not draughty. However, some roof tiles were missing and/or damaged. It was also noted that there was an abundance of cobwebs within the attic space, indicating that it was unlikely that this space is in any regular use by bats. No evidence of bat habitation was noted.

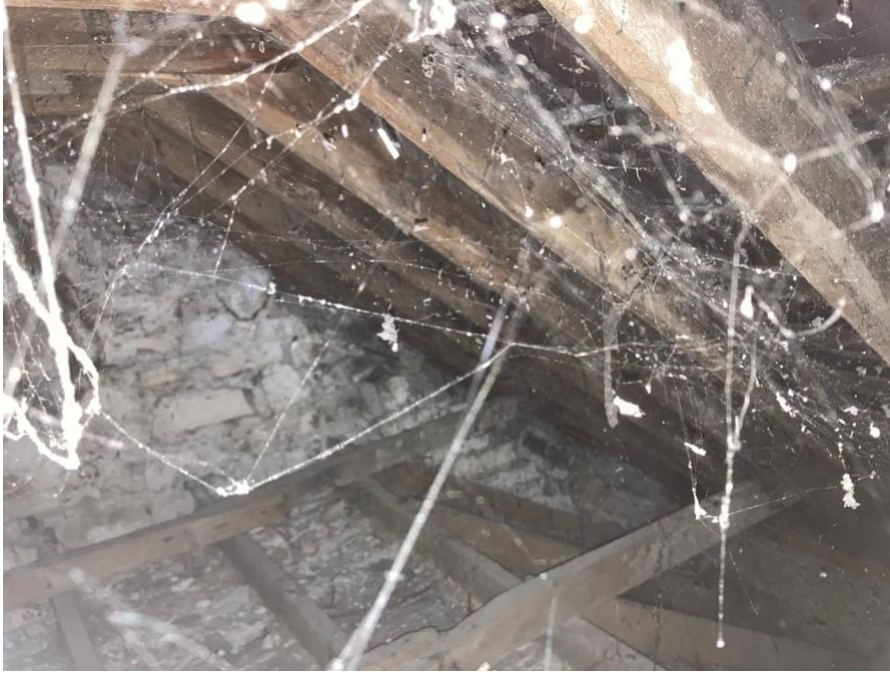
Fig. 3. Cobwebs on roof beams within attic.

While the building is suitable for bat habitation and there are areas where ingress and egress would be possible, no signs of any bat activity were found within this building. It is the conclusion of the author that this building is not in use by bats and does not contain a bat roost. This building may therefore be dismantled without risk of impacts to bat species.

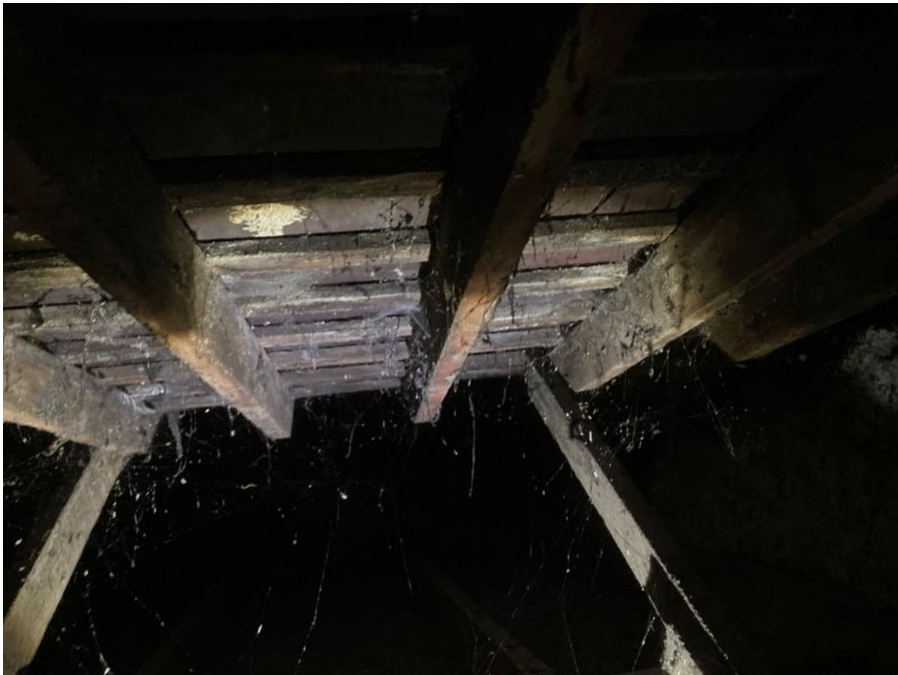
Fig. 4. A view of roof underside showing cobwebs.
