1.4 Topography and Site Characteristics

1.5 Proposed Development

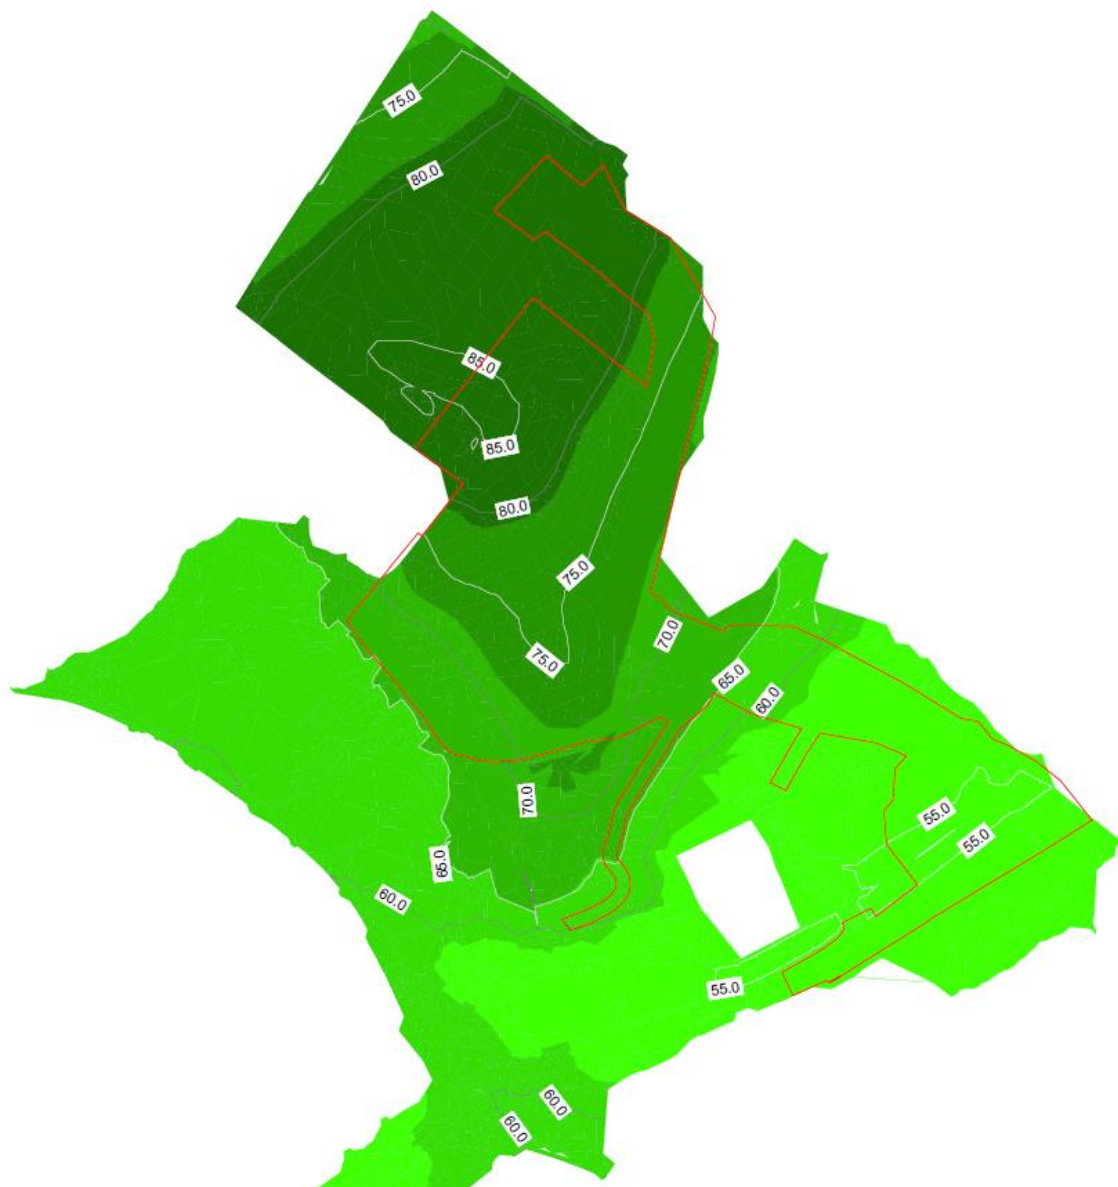
Figure 1-3: Elevation map

The site is mainly undeveloped. Site levels (excluding road embankments and the Ulster Canal and River Shambles), generally range between 55.84m AOD to 85.89m AOD, see figure below for elevation map.
